**Laboratory Investigations of the Oldest Concrete Pavement in America –
Applied Geology in Civil Engineering**

Prepared for the 69th Highway Geology Symposium, September 2018

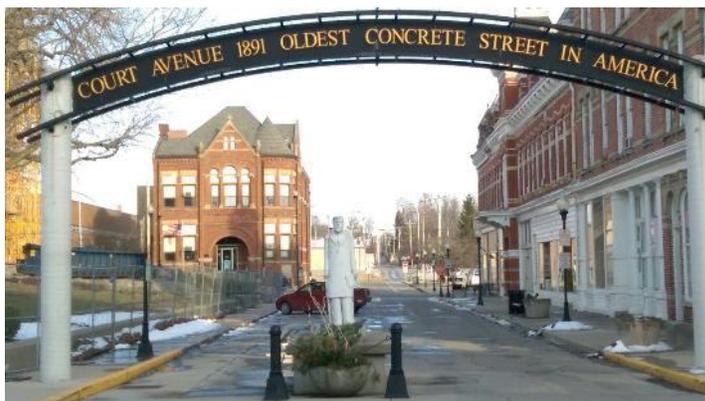
Figure 1 – recent photograph of Court Avenue (a) and photograph of George Bartholomew, date unknown (b) (photos accessed from <http://explorer.acpa.org/explorer/places/united-states/ohio/bellefontaine/street/old-us-30-lincoln-highway/>)

This paper primarily presents data and results of petrographic analysis performed by AET on historic concrete pavement from Bellefontaine, Ohio. The pavement from Court Avenue was placed in 1893 and is the oldest known example of portland cement concrete pavement (PCCP) in the United States (Figure 1, a). The laboratory study was envisaged by the ACPA and involved three other entities, including: Braun Intertec Corp., Oregon State University, and the University of Toronto. Bellefontaine, located in west-central Ohio, lies directly in a severe freeze-thaw environment according to the American Concrete Institute (ACI). The longevity of the pavement in such an environment is a testament to the material's durability and the ACPA felt it warranted an in-depth study. The obvious question to be answered: what characteristics allowed the concrete to last 125 years? The paper also draws comparisons between the historic pavement and modern PCCP's, which are widely used in highway construction.

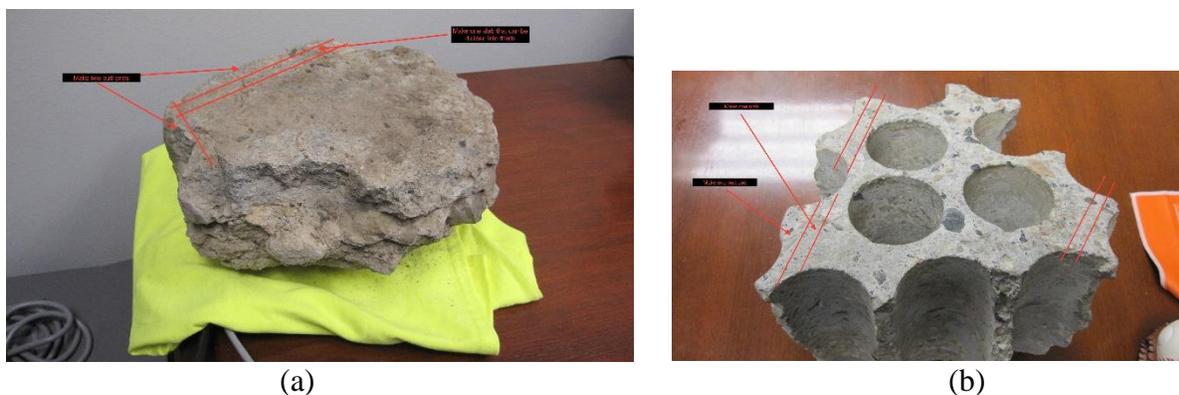
Figure 2 – pre-submittal photos of intact concrete pavement segment (a) and previously-cored segment (b) (photos supplied by the ACPA)

Two large segments of full-depth pavement were received by AET in summer of 2016. One of the segments was unadulterated (Figure 2, a) and one had been previously core sampled and exhibited several cylindrical core hollows (Figure 2, b). Both pavement segments were fairly large; the intact sample measured approximately 12" x 12" and the previously-cored segment slightly smaller. Both segments represented a nearly 'full-depth' cross-section of the pavement and were about 6" to 8" thick. The larger non-cored segment was wet saw-cut into several 'slabs' for the laboratory analysis and as display pieces. The slab sections were flattened and polished with loose grit abrasives on a lapidary wheel using water as a lubricant. The slabs were worked from a coarse 80 grit up through progressively finer grits and eventually finished on 600 to produce a matte finish suitable for microscopic observations. The smaller pavement segment was treated in a similar fashion, with smaller slabs and sections sub-sampled.

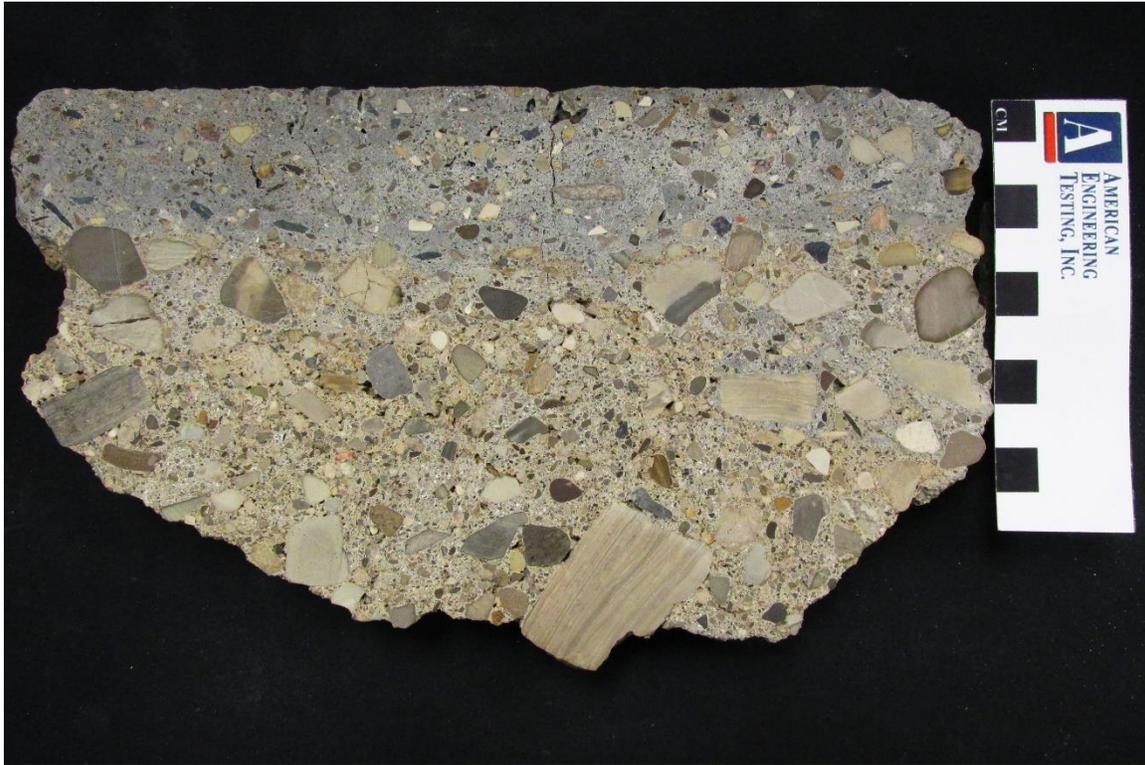
Figure 3 – saw cut and lapped cross-sectional profile of Bellefontaine pavement sample. Note the two-layer construction is evident by both paste coloration and aggregate sizing

Sub-samples and polished slabs were distributed to the University of Toronto, Oregon State University, and Braun Intertec for analyses of their choosing. Upon slab preparation, the distinct layers or 'two-lift' construction of the pavement was obvious (Figure 3). Thin sections of the pavement were produced by AET from the denser wear-course, porous base-course, and the interface between the two concrete placements.

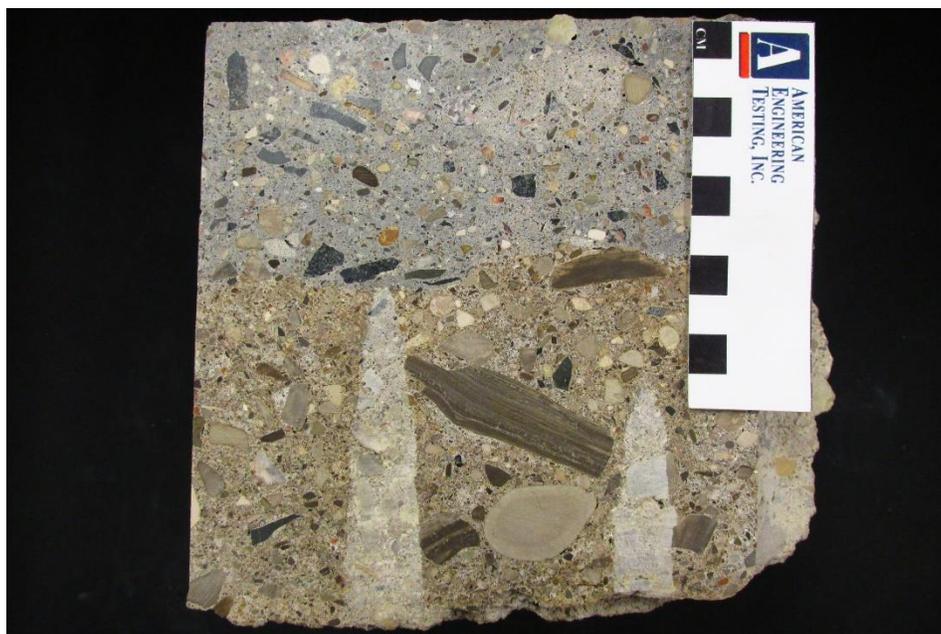
Figure 9 – saw cut and lapped pavement section showing many dark and angular igneous rock particles within the wear-course topping, a few were also noted in the base layer.

The wear-course topping concrete visually contained a lesser amount and finer coarse aggregate relative to the base concrete. This was consistent with the general paste-rich appearance of the topping compared to the more paste-lean base layer. The topping layer contained a 12 mm (1/2") nominal sized coarse aggregate that appeared to be a mixture of natural carbonate-rich pea gravel and crushed (?) or angular igneous rock. The pea gravel was of similar lithologic composition to that documented in the base concrete. The abundant angular igneous particles consisted primarily of a dark-colored amphibole-bearing gabbro and lighter-colored granitic lithology. It is not known if the igneous material was a natural feature of local gravel deposits at that time or was intentionally added to the topping mixture to add durability. As can be seen in Figure 9, the dark igneous particles were primarily present within the topping concrete, and a few also residing within the base layer. Like the base concrete aggregates, the coarse aggregate in the wear-course was considered very hard and durable. Without question, the harder siliceous aggregates in the topping would provide an abrasion resistant surface that could withstand the impacts of overhead traffic.

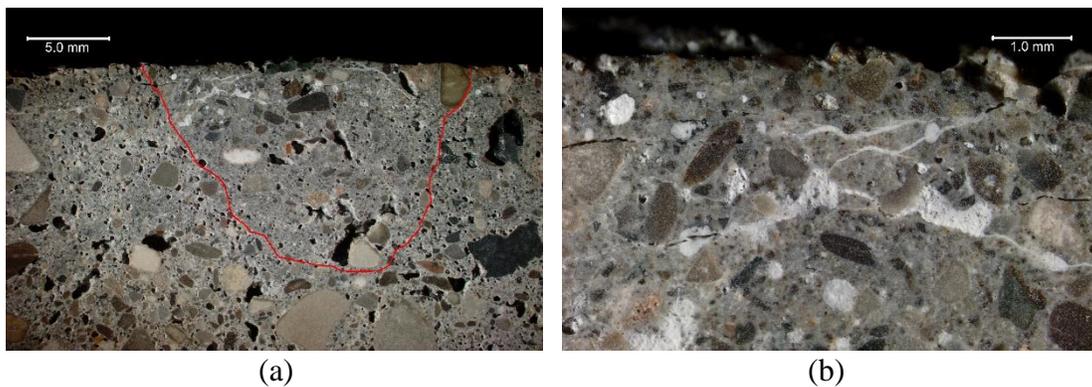
Figure 10 – anomalous paste 'nodule' (red outline) near the pavement surface which lacks fine air voids under 5x mag (a) fine sub-horizontal microcracking within the nodule highlighted by white secondary deposits under 25x mag (b)

Some evidence of freeze-thaw deterioration was documented in both concrete layers, within both the paste and aggregates. Freeze-thaw deterioration is essentially the overcoming of the tensile strength of the concrete by the expansive force of freezing (expanding) water. Of course, the water in concrete would be present within the voids and capillary porosity of the paste. A good entrained air void system typically alleviates these internal pressures by allowing the freezing water to expand into the small spherical voids of the air void system. As previously discussed, the wear-course topping contained an air void system which meets the current recommendations to resist frost damage. However, the paste of the wear-course contained several anomalies which consisted of pebble-sized paste nodules or 'agglomerations' which did not contain any of the observed sub-spherical air voids (Figure 10, a). This is where deterioration was noted, most commonly occurring within these anomalous zones present near the top surface of the pavement. These areas of paste were noted to contain abundant sub-horizontal microcracks – consistent with damage from cyclic freezing and thawing (Figure 10, b).

The origin of these anomalous 'void-free nodules' was not entirely clear, as was the origins of the sub-spherical voids themselves. One hypothesis is that the nodules represent cement which had prematurely hydrated due to the lack of gypsum or sulfate in the cement, as previously discussed. These pre-hydrated paste clumps were not broken up during the mixing/placement of the pavement when the air voids were apparently incorporated or 'entrained' into the mixture. It is plausible though somewhat unlikely, that the mixing alone led to the formation of the entrained-like air voids. Some have speculated that the residues of the crude petroleum used to fire the vertical cement kilns was present in the final ground cement product. Upon mixing with water, the residue acted as a surfactant similar to modern air entraining admixtures, and produced the abundance of microscopic 'bubbles' within the paste. The pre-hydrated 'clumps' would be protected from this mixing and thus contain no bubbles or voids. Despite the origins of the anomalous paste nodules and the voids themselves, the air void system of the wear-course has clearly been essential in protecting the paste from freeze-thaw damage.

It can be seen in Figure 10b that much of the horizontal microcracking (and some surrounding pores) are filled with white-colored secondary deposits. The deposits primarily consisted of portlandite and calcite with some minor ettringite. This 'self-healing' was possible from paste leaching and transport of hydration products within the concrete system. Overall, this freeze-thaw damage within the wear-course was very minor and had little effect on the bulk condition of the examined pavement samples.
